HERITAGE PLACE

NAME OF PLACE: 'ERATYRA'

ADDRESS/LOCATION OF PLACE: 7-19 Kilcunda Road KILCUNDA

HERITAGE OVERLAY NUMBER: HO108

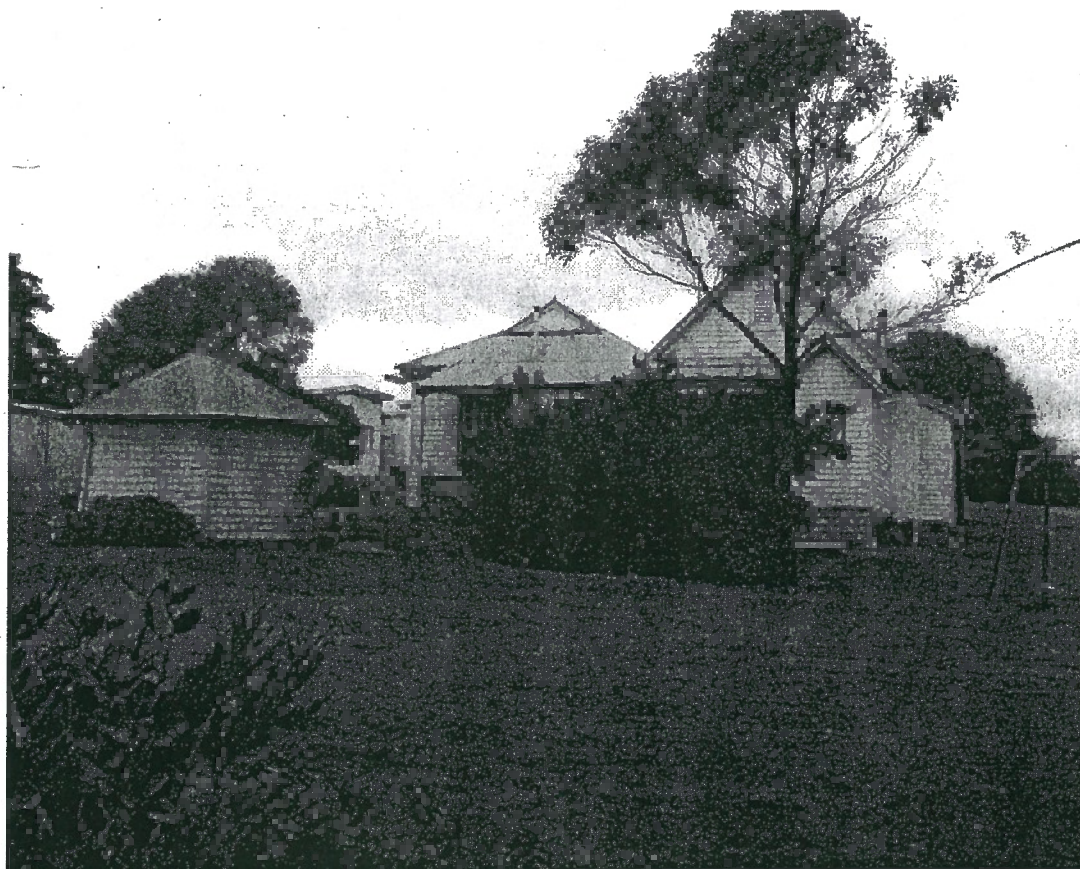
The former school buildings at 7-19 Kilcunda Rd, Kilcunda

Image Date: March 2002

Investigate original external paint colours when due for a repaint.
Remove fibro-cement sheet from front verandah of former teacher's residence.
Other structures on the site may be retained, demolished or altered
